2004 SUBARU FORESTER AWD XS - BLACK

VIN: JF1SG65684H743359 Work Order #: 4494136

MANHEIM AUTO AUCTION

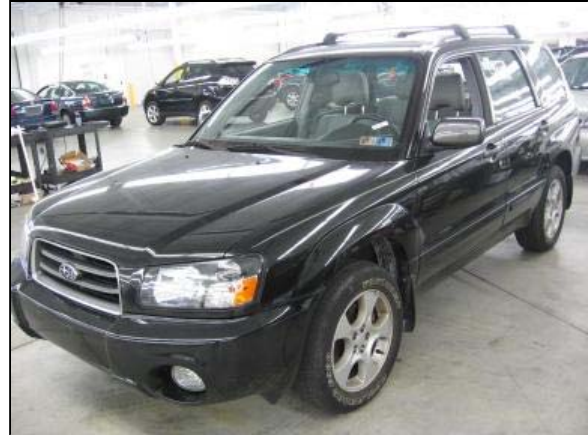
VIN: JF1SG65684H743359
Body Style: 4Dr CUV - Sun Roof
Ext Color/Code: BLACK
Int Color/Code: GRY
Mileage: 13,287
Seller: CHASE VEHICLE EXCHANGE
Certified: No
Condition/Grade: Grade 3, Average
Sale: 63
Lane: 19
Run: 519
Inspection: RDAVIS 10/12/2007
Drivable: Yes
